PRAIRIE DU CHIEN - JORDAN AQUIFER

MONITORING WELL PLAN FOR

WELLS W401, W402, AND W403

**PRAIRIE DU CHIEN - JORDAN AQUIFER
MONITORING WELL PLAN FOR
WELLS W401, W402, AND W403**

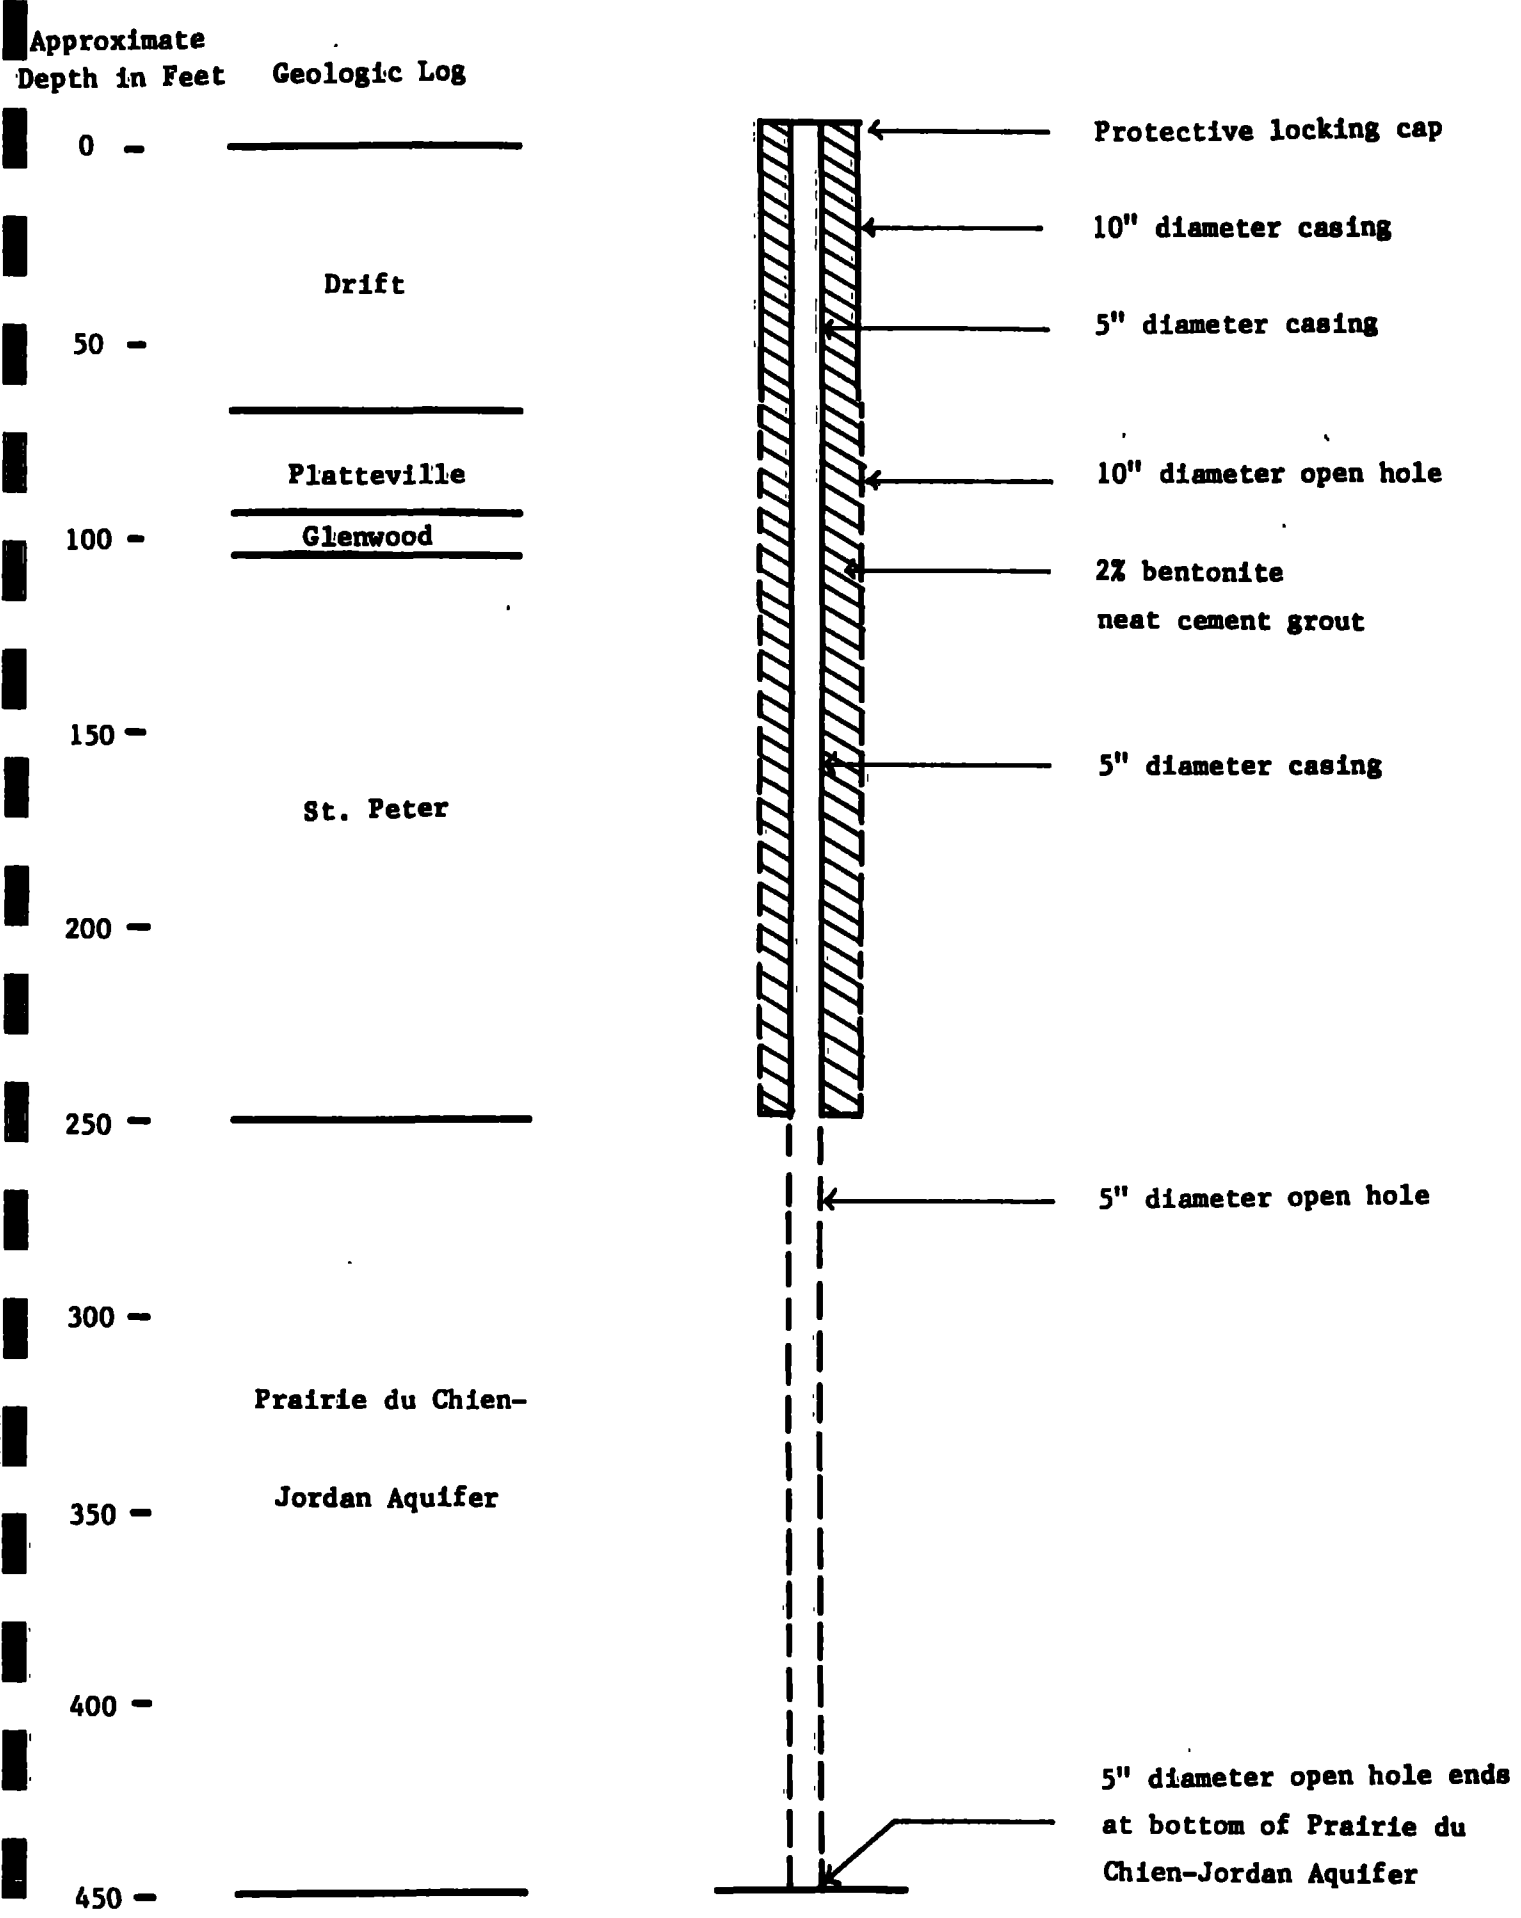
Figure 10 Well W403 Construction Details.

No suitable existing wells were found within 2500 feet of France Avenue at West 38th Street in Minneapolis (W403). Therefore, a new Prairie du Chien - Jordan Aquifer monitoring well will be constructed at Minikahda Vista Park in the City of St. Louis Park (Figure 9). Figure 10 shows the construction details for the new well. Well W403 will penetrate the full thickness of the Prairie du Chien - Jordan Aquifer, and will have a finished diameter of five inches. Well W403 will meet the requirements of the Minnesota Water Well Construction Code, and will provide water level and water quality information representative of only the Prairie du Chien - Jordan Aquifer in accordance with Section 7.2.5 of the RAP.
